**FINAL**  
**Baseline Property Condition**  
**Assessment with Specialist**  
**Reviews of the Mechanical and**  
**Electrical Systems**

958 Broadview Avenue,  
Toronto, Ontario

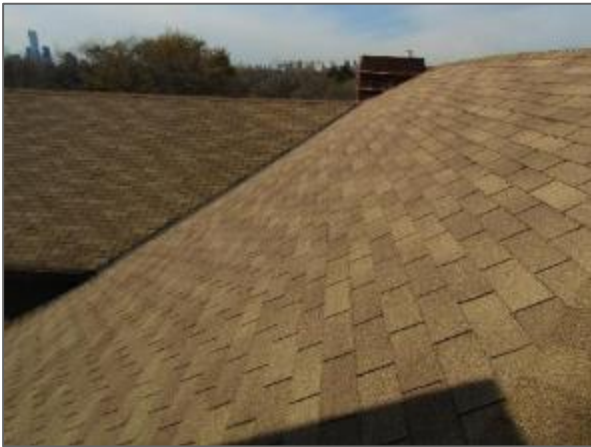
General view of the sloped asphalt-shingled roof system noted atop the Phase 1 (i.e., central) portion of the Site Building.

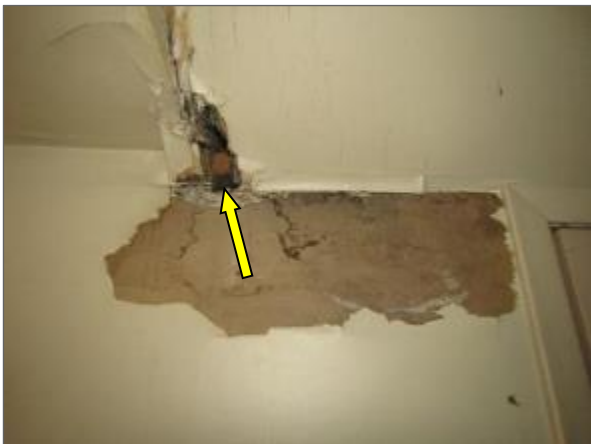
View of an active roof leak noted at the vicinity of the tower portion of Phase 1.

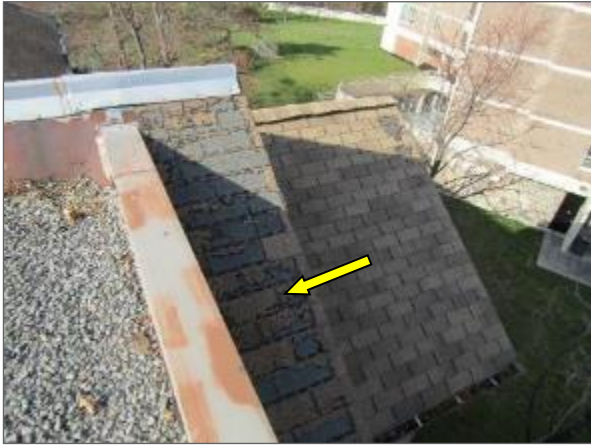
View of the deteriorated asphalt shingles noted at the north portion of the Phase 1, sloped asphalt shingled roof system.

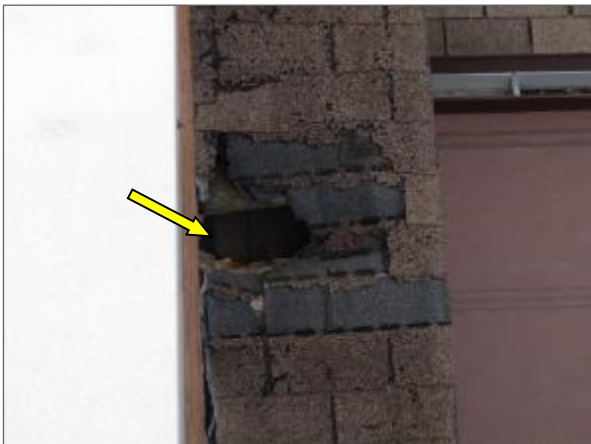
View of a hole through the sloped asphalt roof system noted at the north portion of the Phase 1 portion of the Site Building.

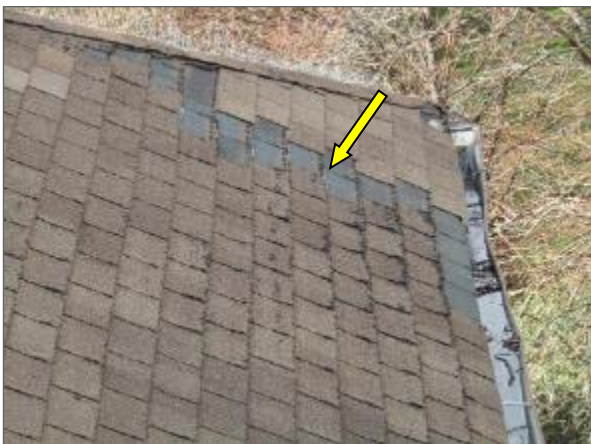
View of the missing asphalt shingles noted at the northwest portion of the sloped asphalt shingled roof system serving the Phase 1 portion of Site Building.

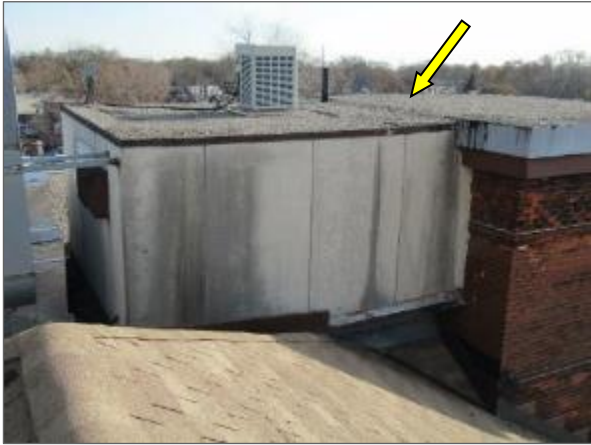
General view of the BUR mechanical penthouse noted atop the Phase 1 portion of the Site Building.

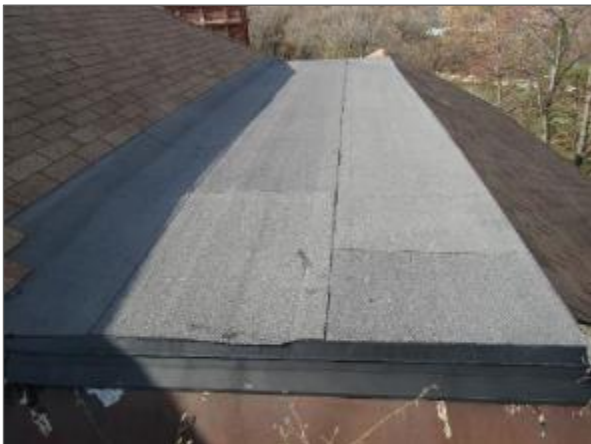
General view of the modified bitumen roof system noted atop the north-central portion of the Phase 1 portion of the Site Building.

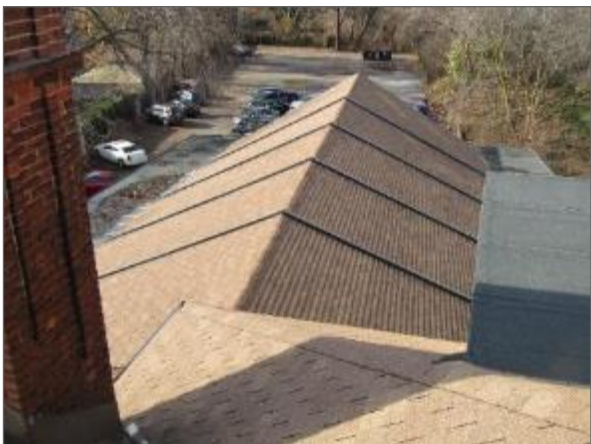
General view of the sloped asphalt roof system serving the Phase 2 (i.e., west) portion of the Site Building.

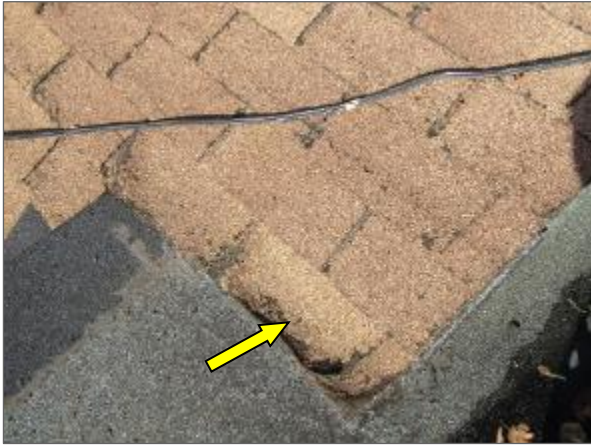
View of the typical worn/aged asphalt roof shingles serving the Phase 2 portion of the Site Building.

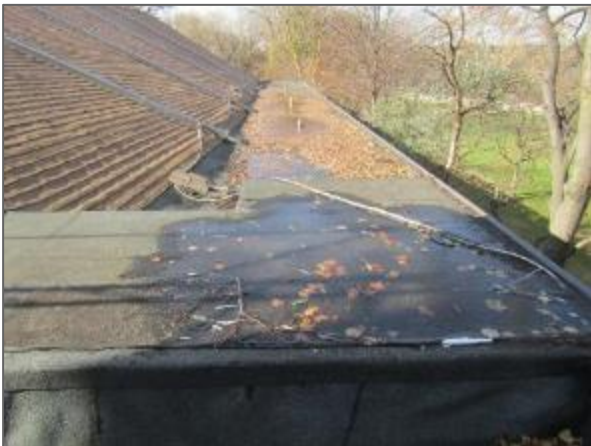
General view of the modified bitumen roof system noted at the perimeters of the Phase 2 portion of the Site Building.

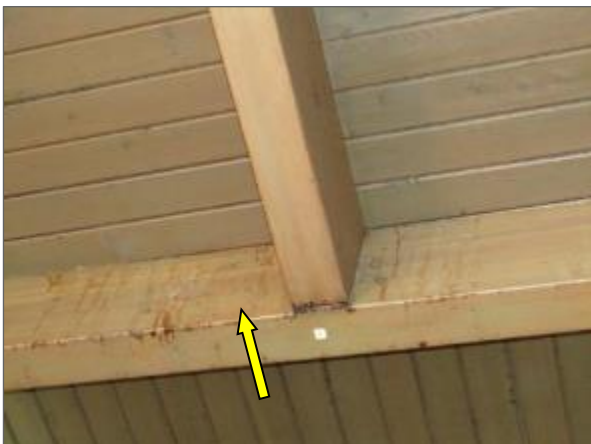
View of a roof leak through the modified bitumen roof system into the Grand Hall foyer noted within the Phase 2 portion of the Site Building.

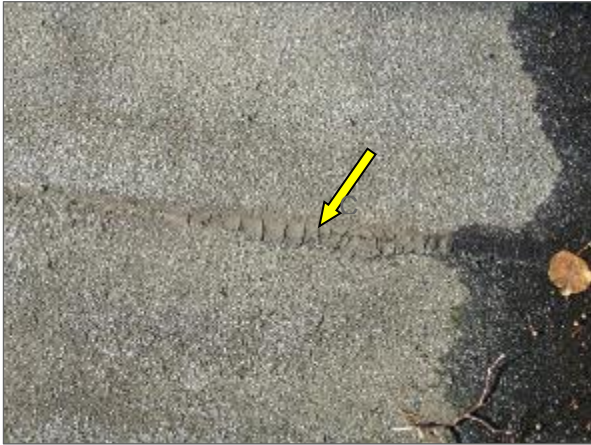
View of the typical cracked seals and worn/aged modified bitumen membrane serving the flat roof areas of Phase 2.

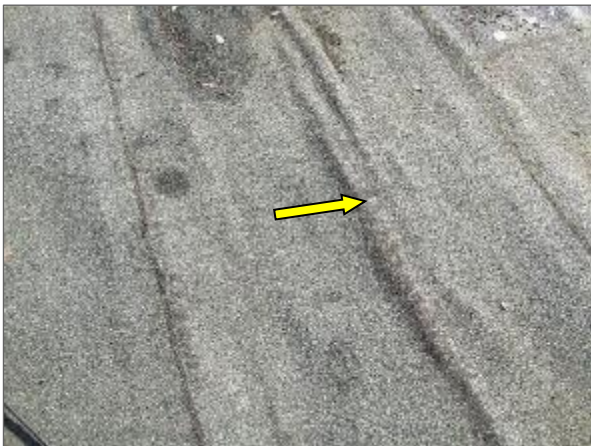
View of wrinkling of the modified bitumen membrane noted at the southeast portion of the modified bitumen roof system serving the Phase 2 portion of the Site Building.

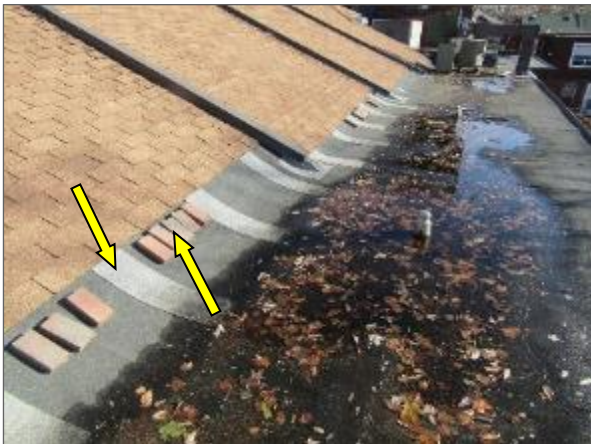
View of the previous patch repairs and debris (i.e., bricks) noted at the south portion of the modified bitumen roof system serving the Phase 2 portion of the Site Building.

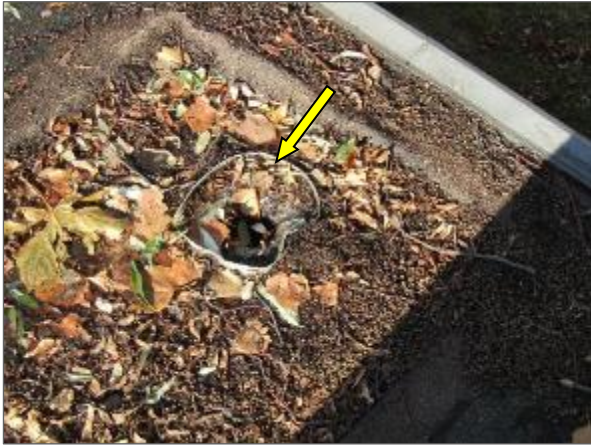
View of a missing roof drain strainer and accumulated organic debris (i.e., leaves) noted at the northwest portion of the modified bitumen roof system serving the Phase 2 portion of the Site Building.

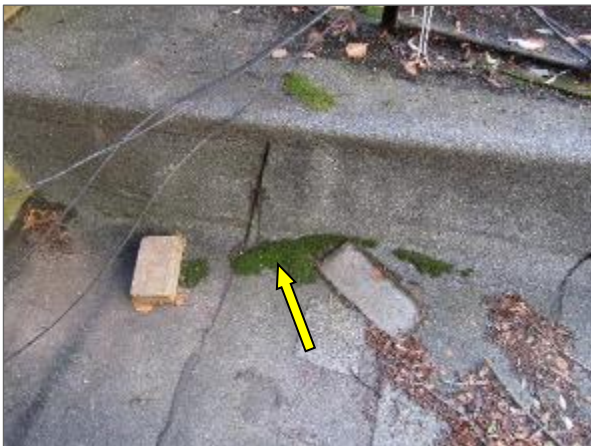
View of moss growth noted at the northeast portion of the modified bitumen roof system serving the Phase 2 portion of the Site Building.

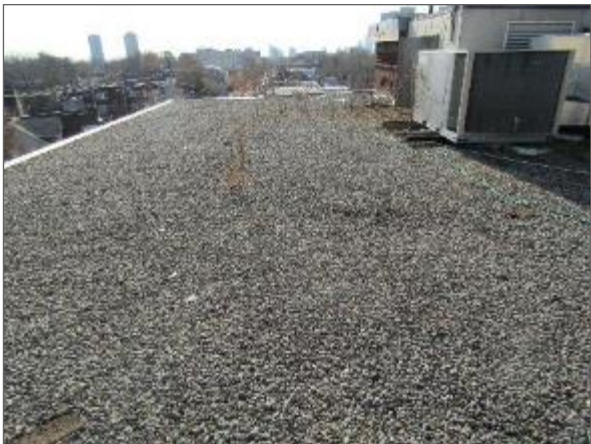
General view of the BUR system serving the Phase 3 (i.e., east) portion of the Site Building.

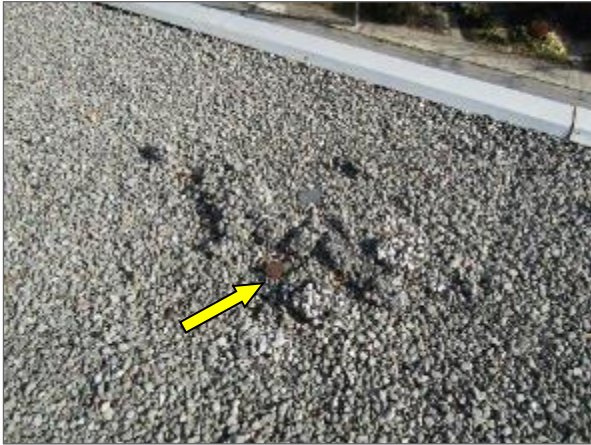
View of asphalt bleed-through noted at the east portion of the BUR system serving the Phase 3 portion of the Site Building.

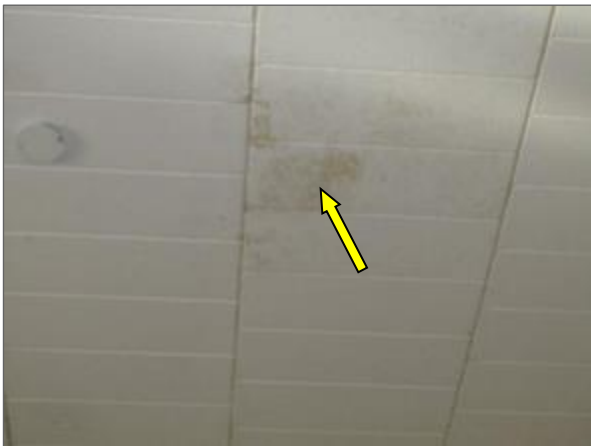
View of moisture staining on the underside of the concrete panel roof deck (i.e., indicating a previous roof leak) noted within the "Youth Room" on the top floor of the Phase 3 portion of the Site Building.

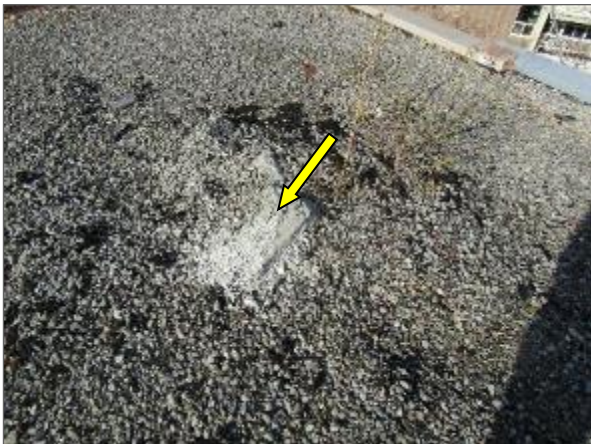
View of a cement deposit (i.e., used as a temporary leak repair) at the northeast portion of the BUR system serving the Phase 3 portion of the Site Building.

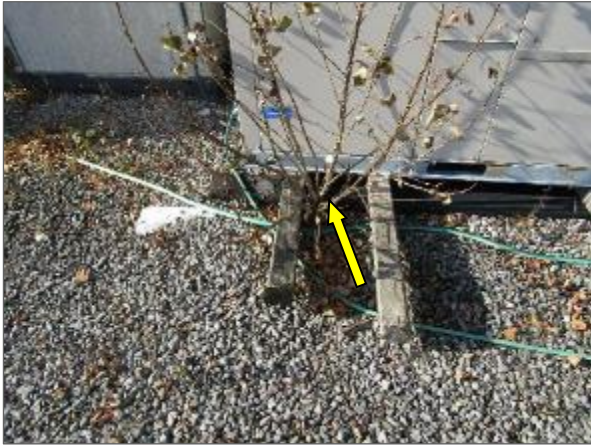
View of the vegetation growth noted at the central portion of the BUR system serving the Phase 3 portion of the Site Building.

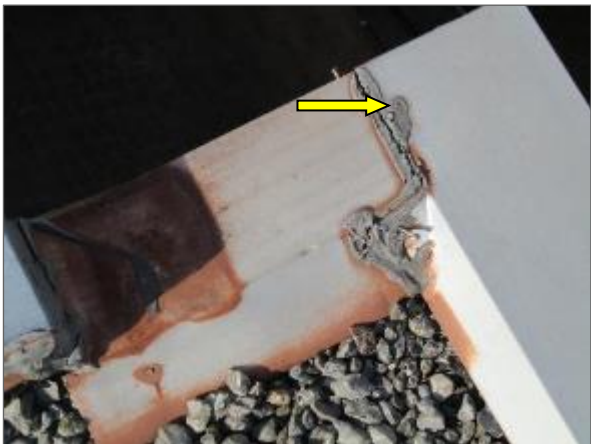
View of a cracked joint sealant serving the perimeter metal flashing serving the phase 3 portion of the Site Building.

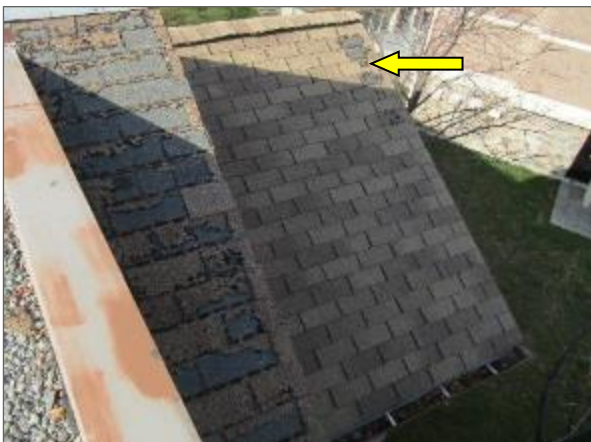
General view of the upper sloped asphalt-shingled roof system serving the Phase 4 (i.e., northeast) portion of the Site Building.

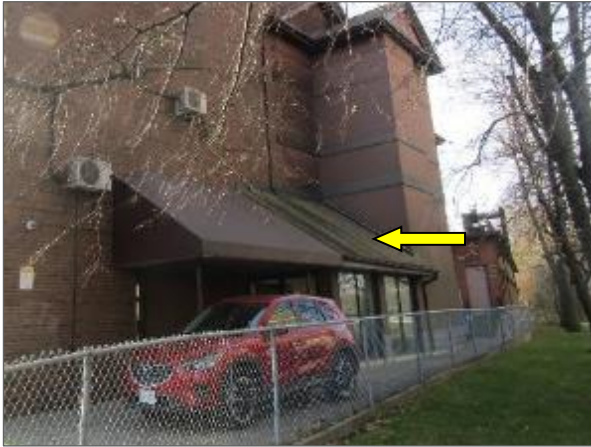
General view of the lower sloped asphalt-shingled roof system serving the Phase 4 (i.e., northeast) portion of the Site Building.

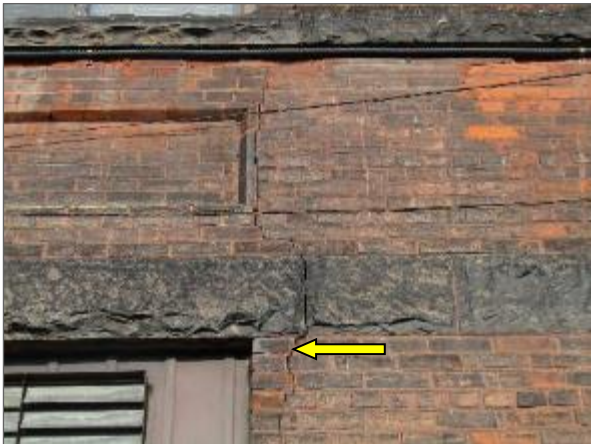
View of vertical/step cracking in the multi-wythe brick masonry wall noted on the south elevation of the Phase 1 portion of the Site Building.

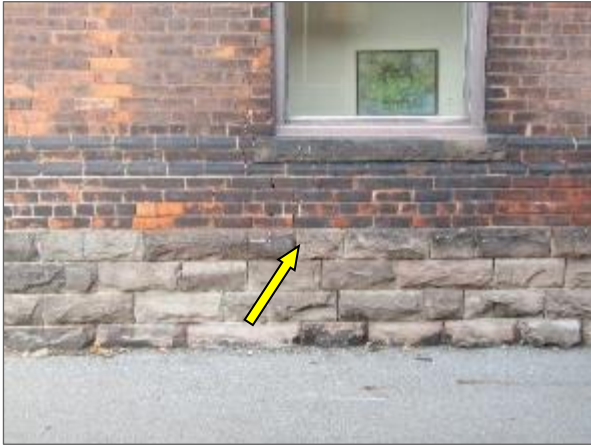
View of step cracking in the multi-wythe brick masonry and architectural block masonry wall noted on the south elevation of the Phase 1 portion of the Site Building.

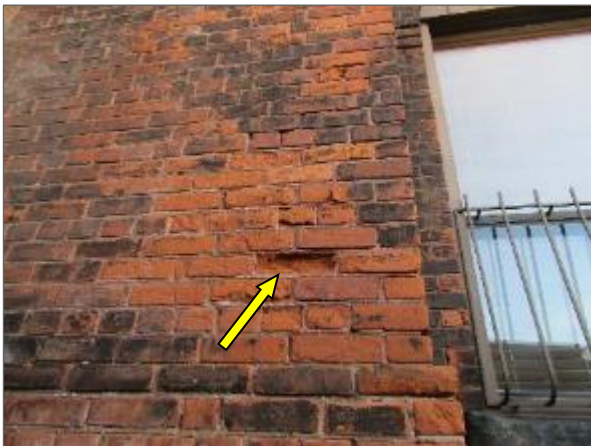
View of the spalled multi-wythe brick masonry noted on the west elevation of the Phase 1 portion of the Site Building.

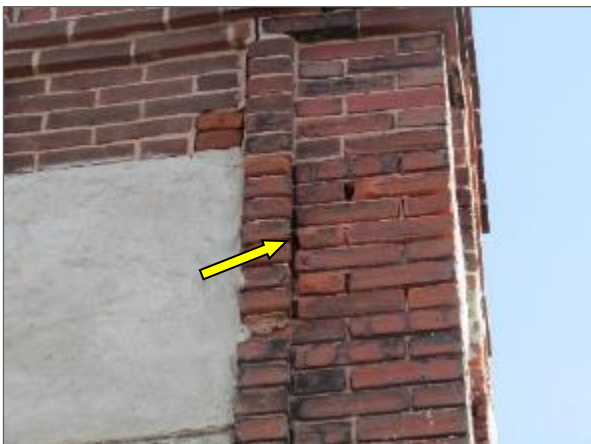
View of the missing mortar joints multi-wythe brick masonry noted on the west elevation of the Phase 1 portion of the Site Building.

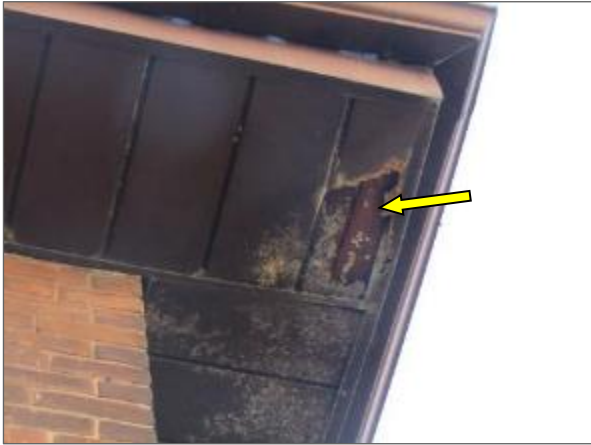
View of the corroded metal soffit noted at the southwest corner of the Phase 1 portion of the Site Building.

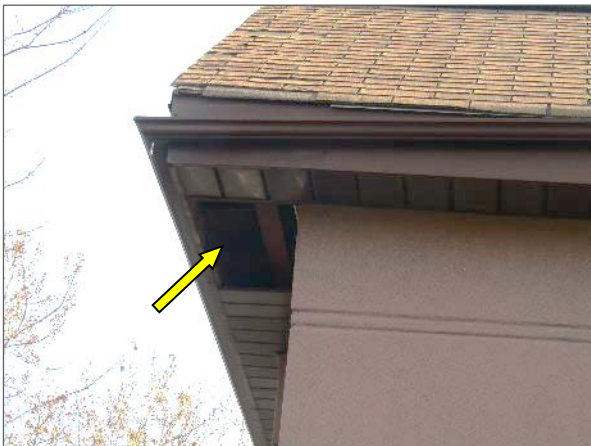
View of missing metal panels serving the soffit noted at the northwest corner of the Phase 1 portion of the Site Building.

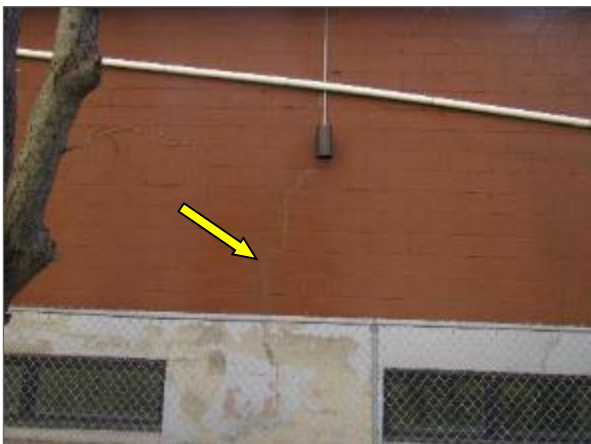
View of a vertical crack on the concrete block masonry wall noted on the north elevation of the Phase 2 portion of the Site Building.

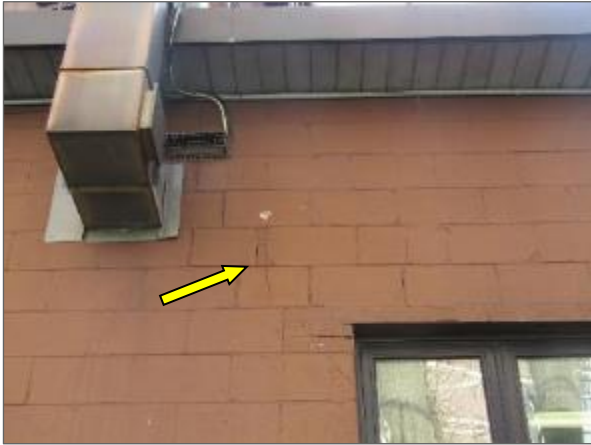
View of step cracking on the concrete block masonry wall noted on the north elevation of the Phase 2 portion of the Site Building.

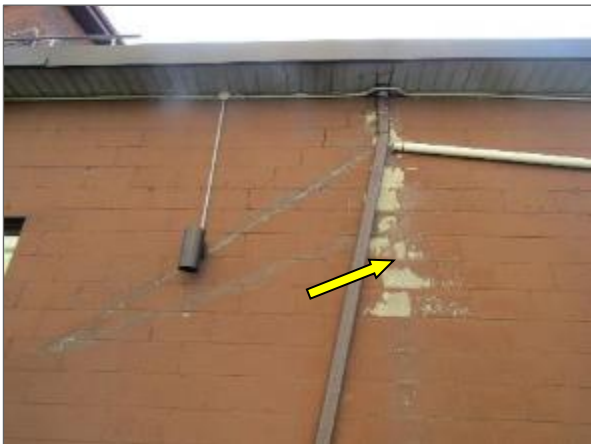
View of moisture damaged/spalled concrete block masonry noted on the north elevation of the Phase 2 portion of the Site Building.

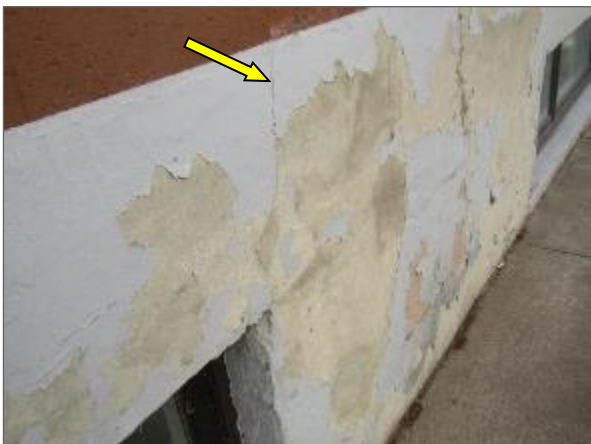
View of the cracked cement parging and peeling paint noted on the north elevation of the Phase 2 portion of the Site Building.

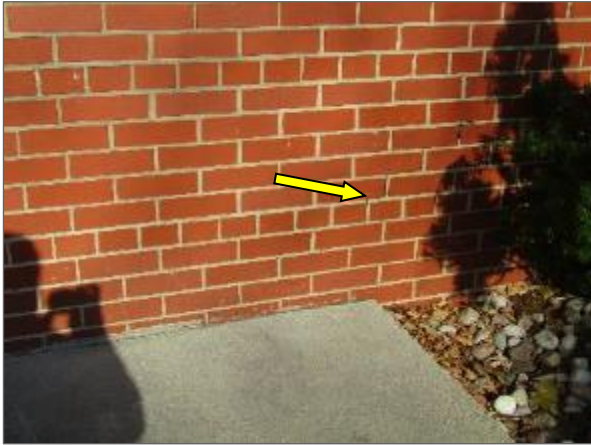
View of the step cracking on the brick masonry wall noted on the south elevation of the Phase 2 portion of the Site Building.

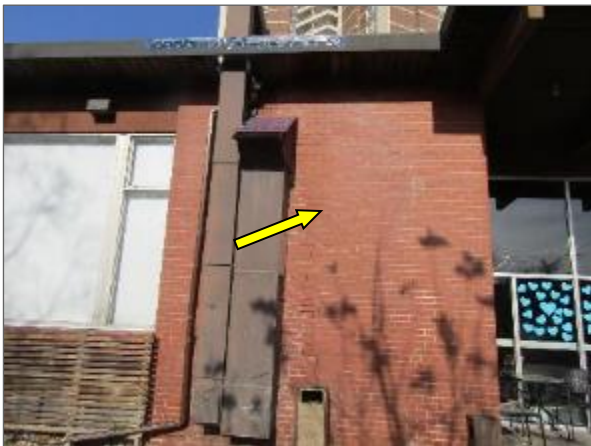
View of the efflorescence stained brick masonry noted on the south elevation of the Phase 2 portion of the Site Building.

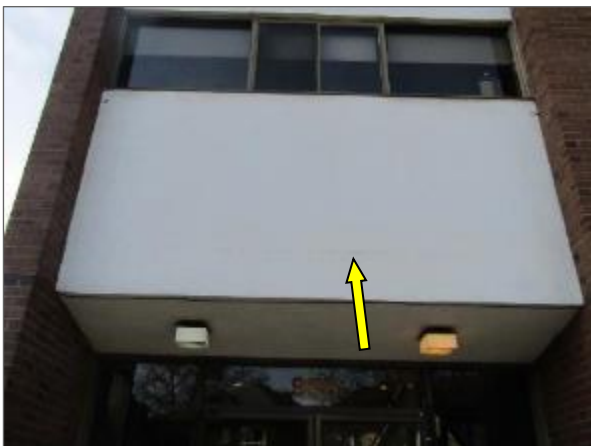
View of the cracks in the cement parking noted on the east elevation of the Phase 3 portion of the Site Building.

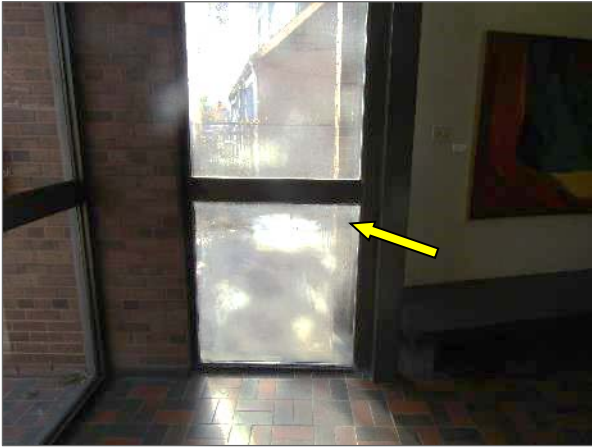
View of the failed IG window unit noted on the south elevation of the Phase 3 portion of the Site Building.

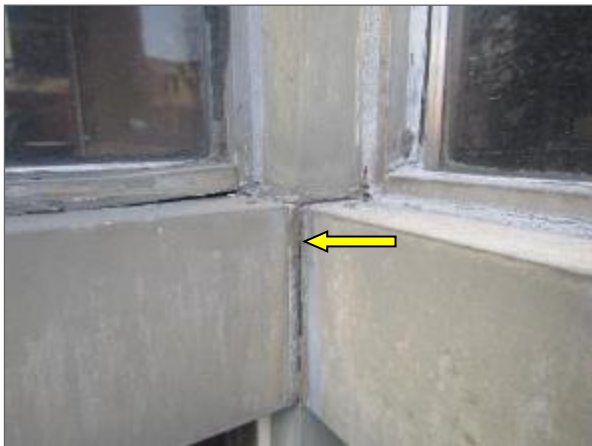
View of cracked perimeter window sealant noted on the south elevation of the Phase 3 portion of the Site Building.

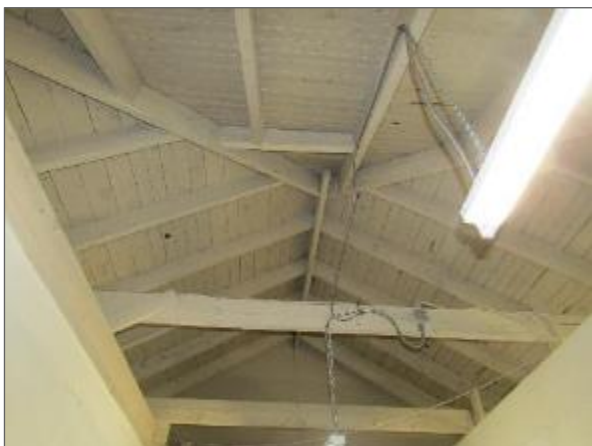
General view of the wood roof joists and decking noted within the gun range of the Phase 1 portion of the Site Building.

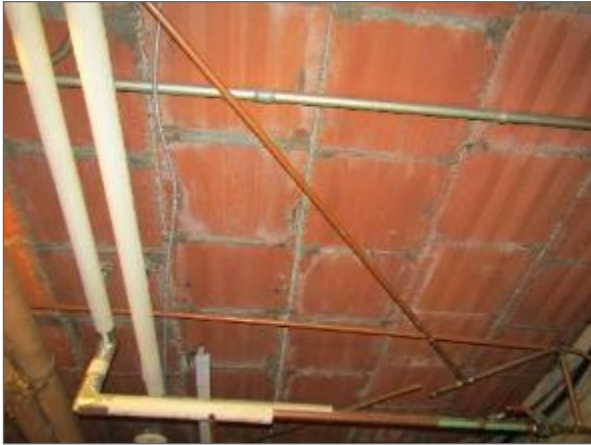
General view of the flat arch slab construction noted within the basement level of the Phase 2 portion of the Site Building.

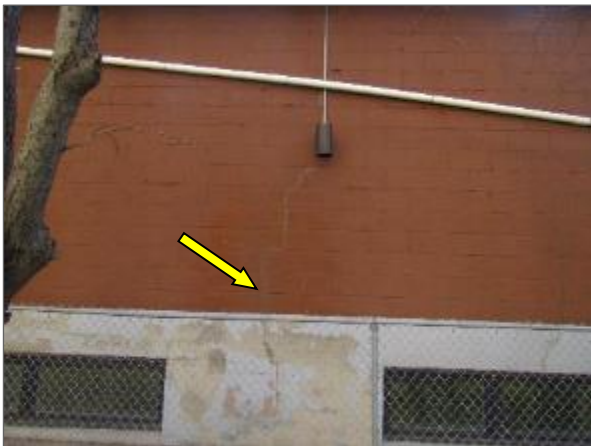
View of a vertical crack on the concrete block masonry wall noted on the north elevation of the Phase 2 portion of the Site Building.

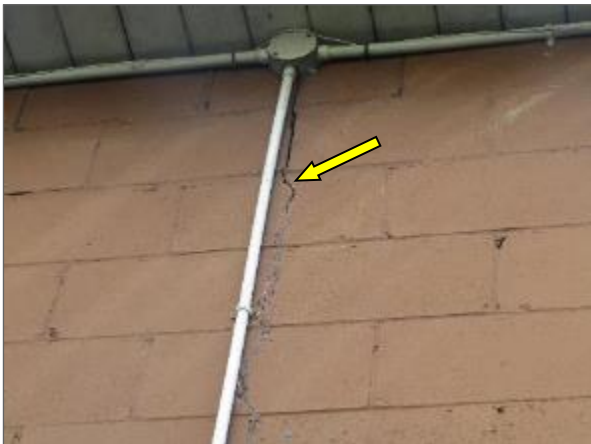
View of a vertical crack on the concrete block masonry wall noted on the north elevation of the Phase 2 portion of the Site Building.

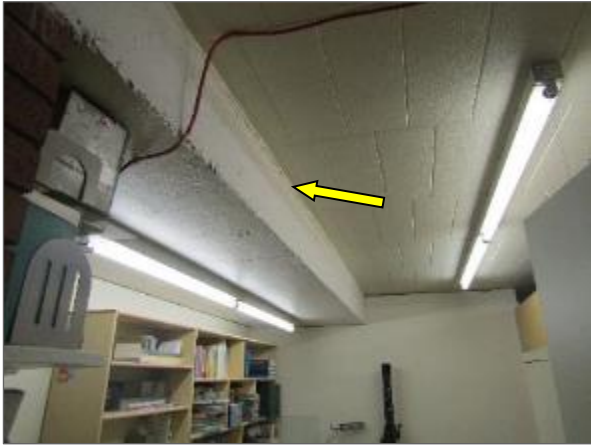
General view of the cast-in-place concrete beam noted within the basement level archive room of the Phase 3 portion of the Site Building.

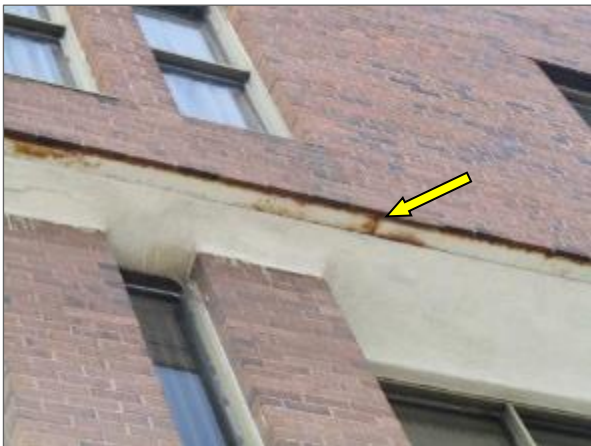
View of the corrosion on the steel beam noted on the east elevation of the Phase 3 portion of the Site Building.

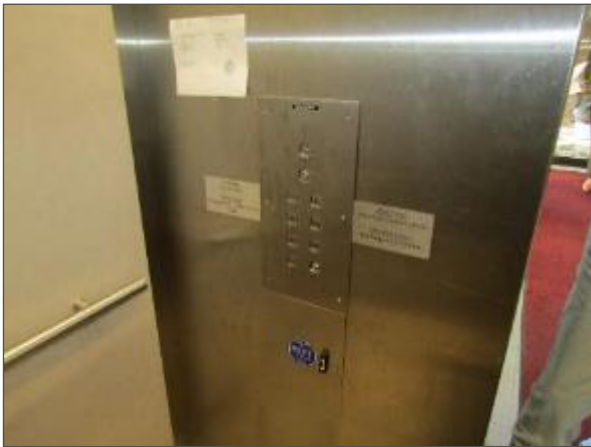
View of the interior of elevator cab.

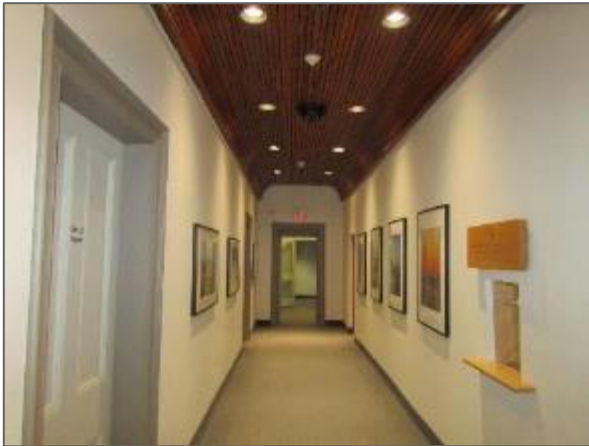
General view of the interior finishes noted within a typical corridor in the Phase 1 portion of the Site Building.

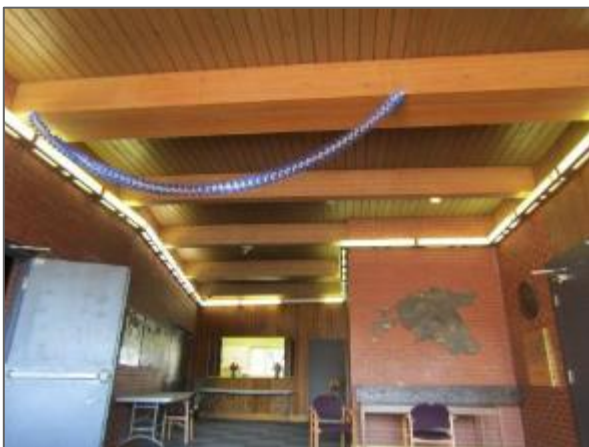
General view of the interior finishes noted within the Grand Hall foyer in the Phase 2 portion of the Site Building.

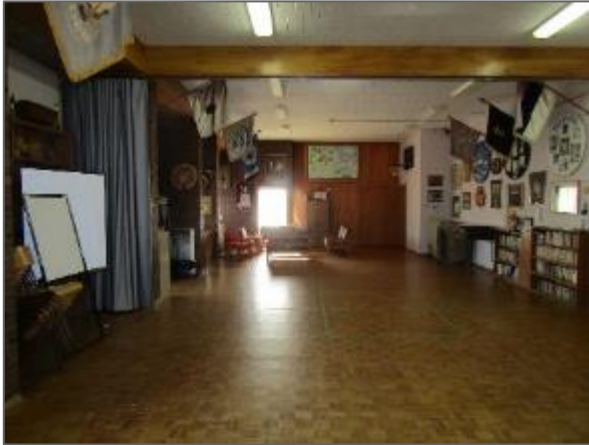
General view of the youth room located in the Phase 3 portion of the Site Building.

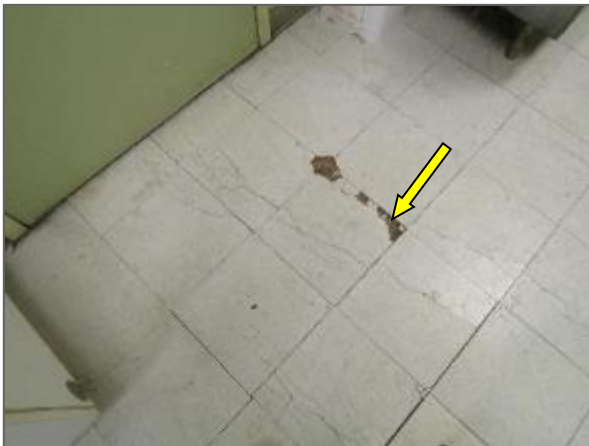
View of the cracked/deteriorated vinyl floor tiles noted in the kitchen area of the Phase 2 portion of the Site Building.

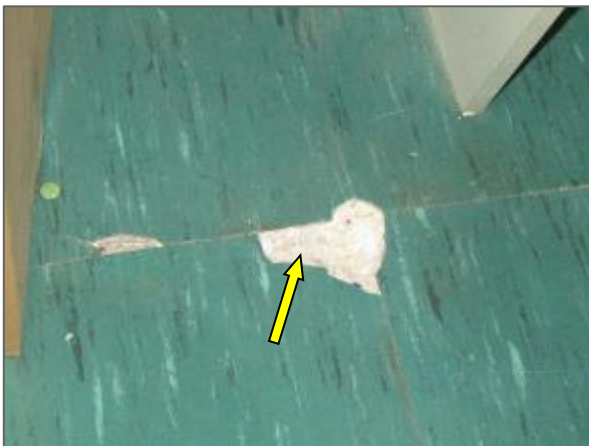
View of deteriorated vinyl floor tile noted within a basement level classroom in the Phase 2 portion of the Site Building.

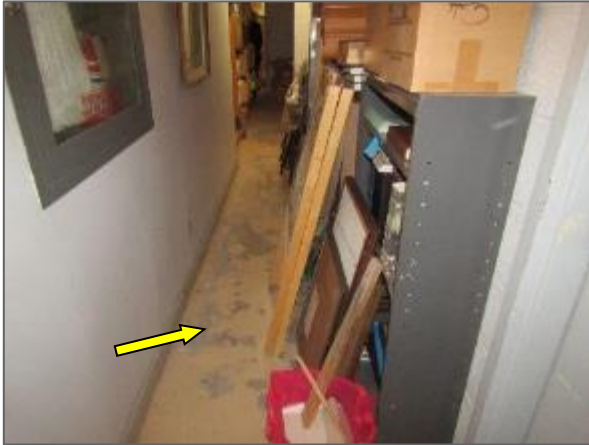
View of the deteriorated epoxy finished floor slab noted in the basement level of the Phase 3 portion of the Site Building.

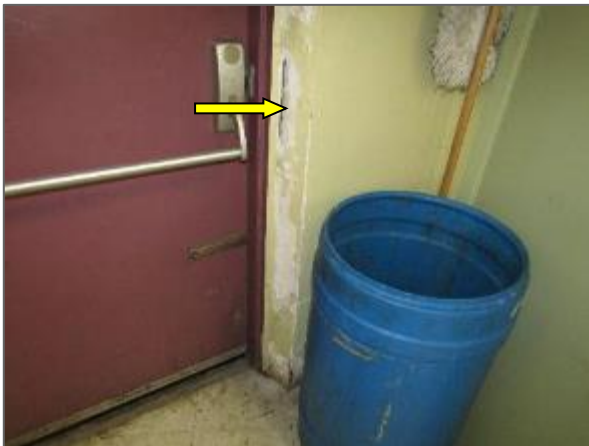
View of the moisture damaged gypsum wall noted within the kitchen area of the Phase 2 portion of the Site Building.

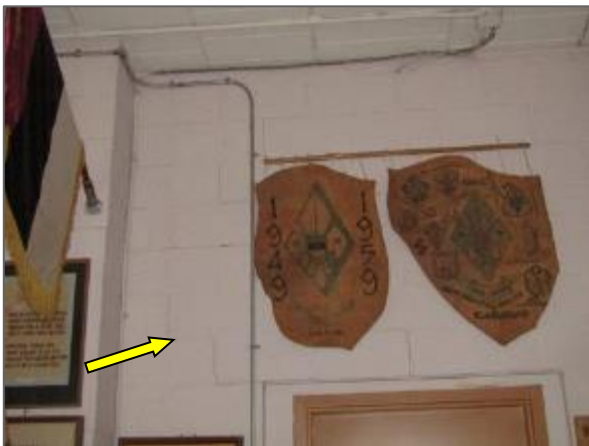
View of step cracking on the concrete block masonry wall noted within the youth room located in the Phase 3 portion of the Site Building.

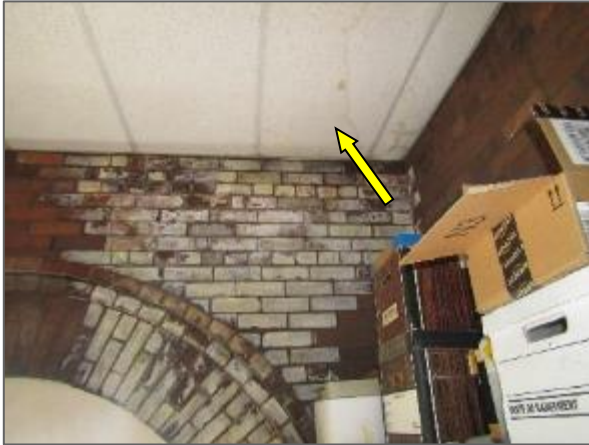
View of the water stained ceiling tiles and brick masonry noted within the tower of the Phase 1 portion of the Site Building.

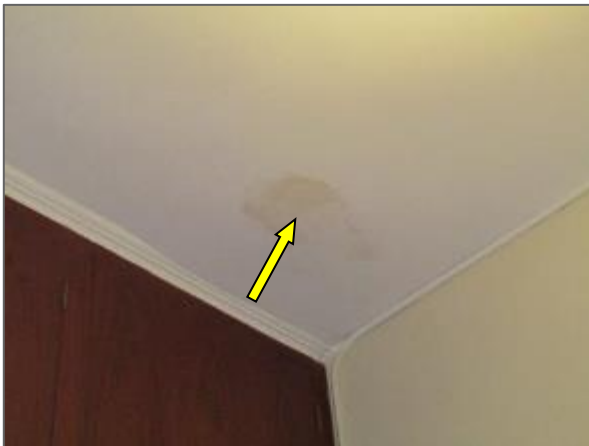
View of the water stained gypsum ceiling noted in a corridor of the Phase 3 portion of the Site Building.

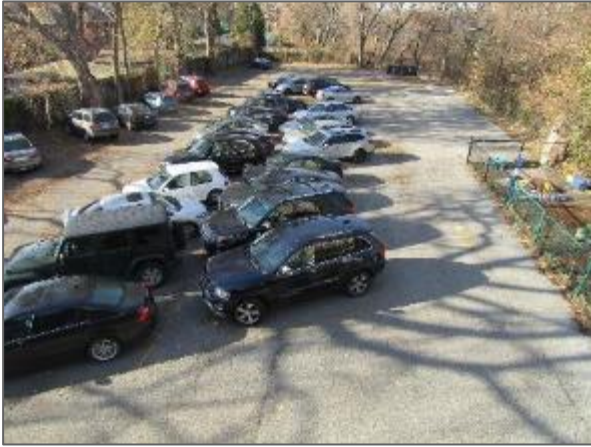
General view of the asphalt paved parking area located at the west portion of the Site.

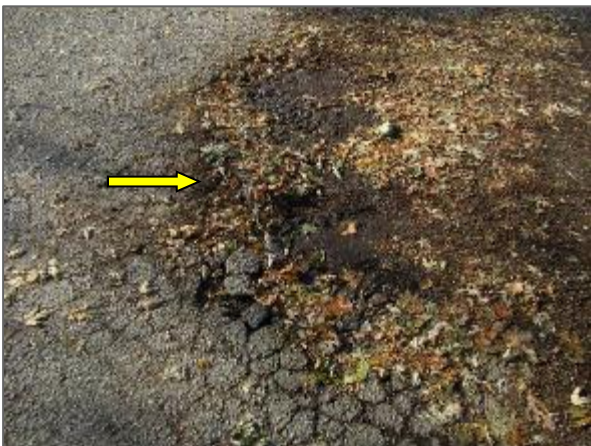
View of the deteriorated asphalt pavement noted at the west portion of the Site.

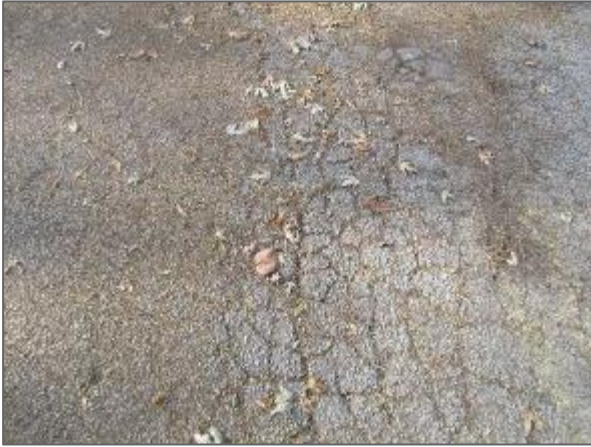
View of alligator cracking in the asphalt pavement noted at the west portion of the Site.

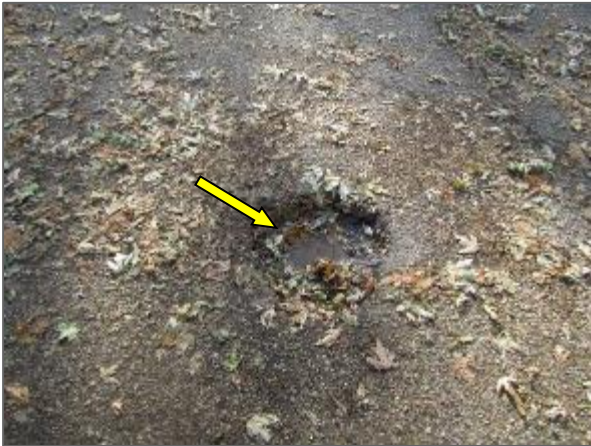
View of alligator cracking in the asphalt paved parking area noted at the west portion of the Site.

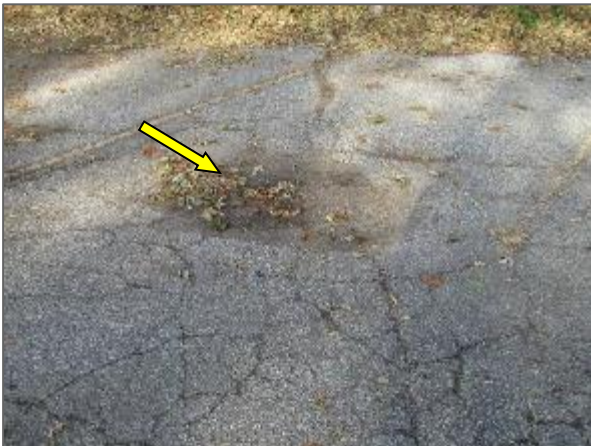
View of a depression in the asphalt paved parking area noted at the west portion of the Site.

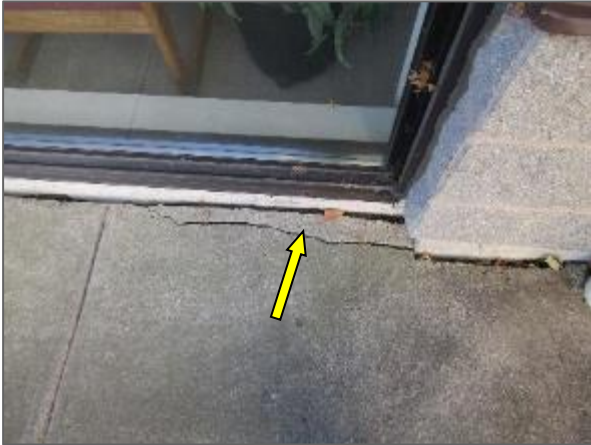
View of a crack in the cast-in-place concrete walkway noted adjacent to the north elevation of the Site Building.

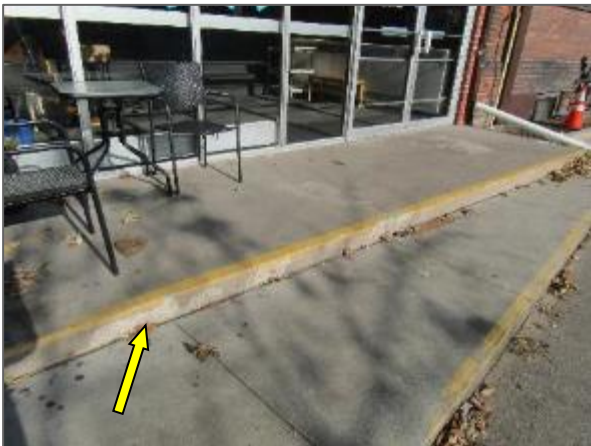
View of the spalled cast-in-place concrete walkway noted adjacent to the south elevation of the Site Building.

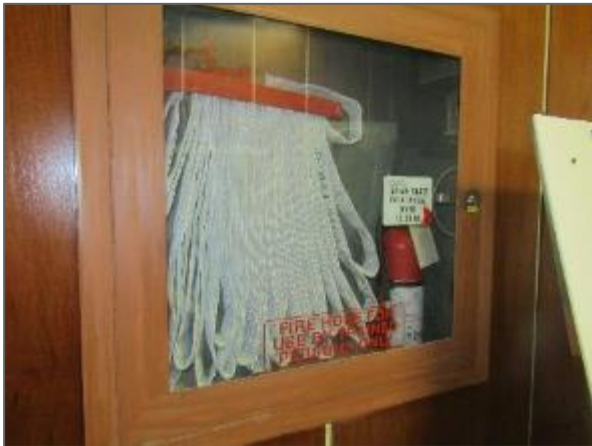
View of a typical fire hose cabinet complete with fire extinguisher noted in the east portion of the Site Building.

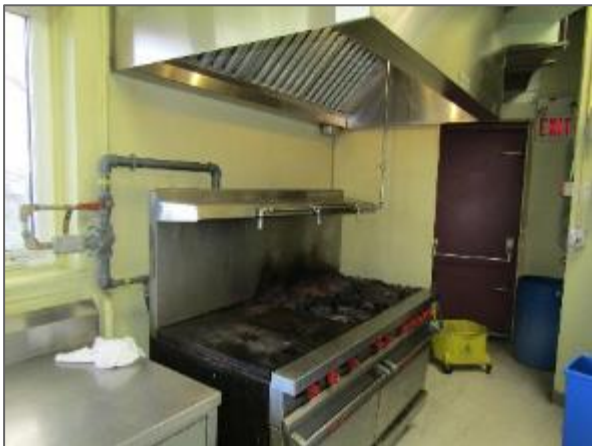
View of the fire suppression equipment noted above the cooking ranges.

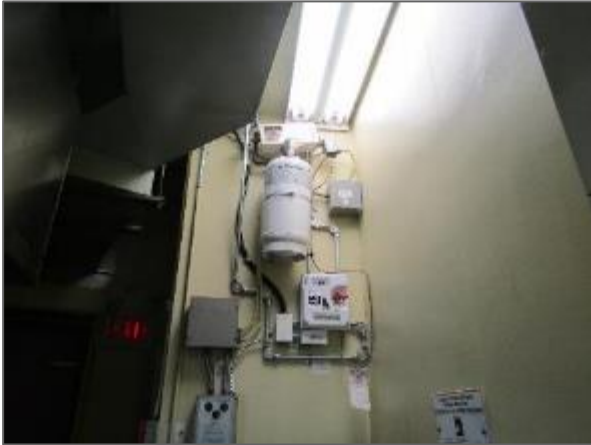
View of the fire suppression equipment noted within the kitchen.

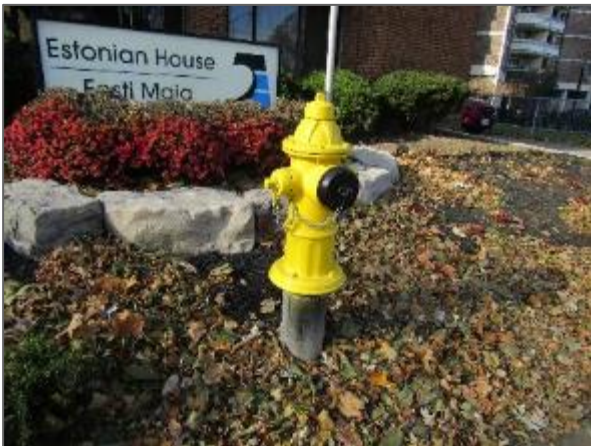
View of the fire hydrant noted at the east portion of the Site.

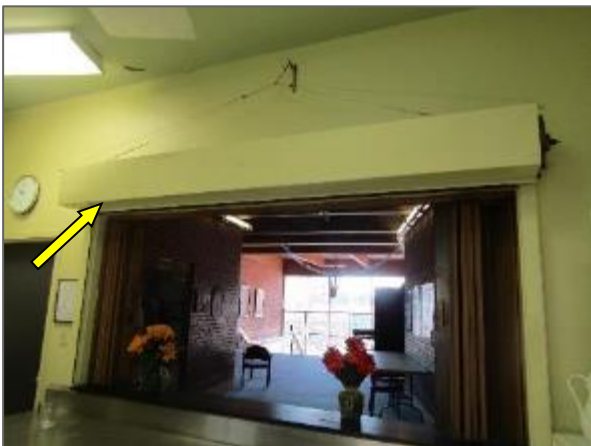
View of the fire shutter noted within the main kitchen area.

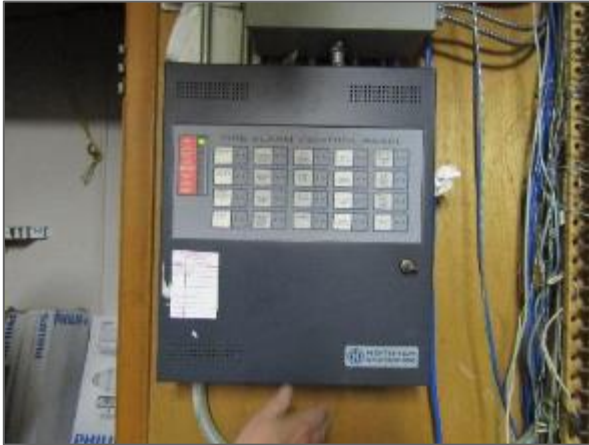
View of the fire alarm control panel noted in the basement level electrical room.

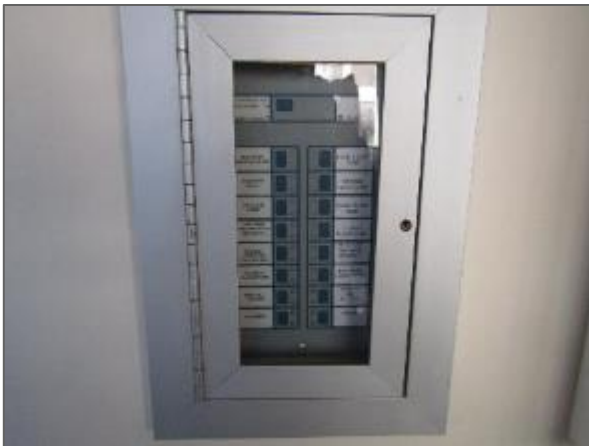
View of the annunciator panel located in the ground floor elevator lobby.

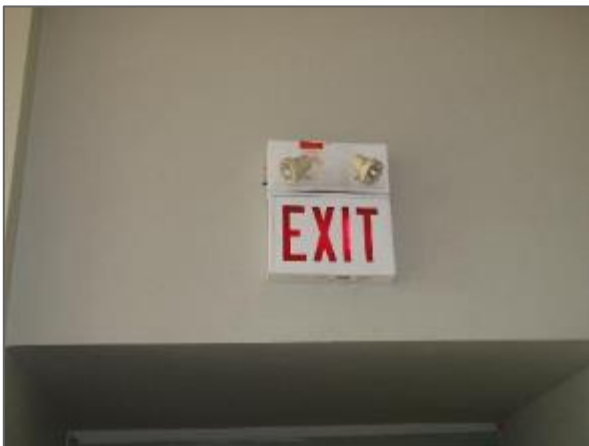
View of the typical illuminated exit signage and emergency lighting noted throughout the Site Building.

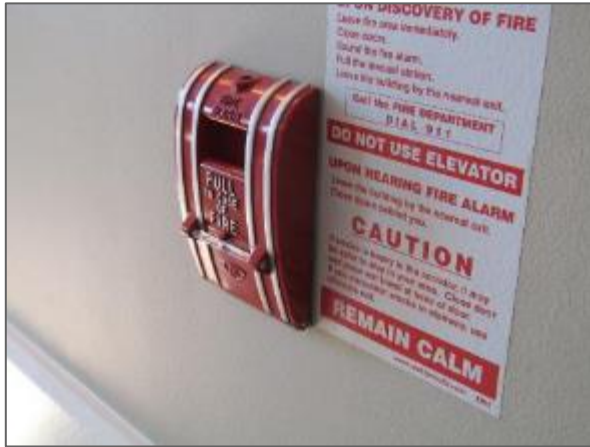
View of a typical manual pull station noted at strategic locations throughout the Site Building.

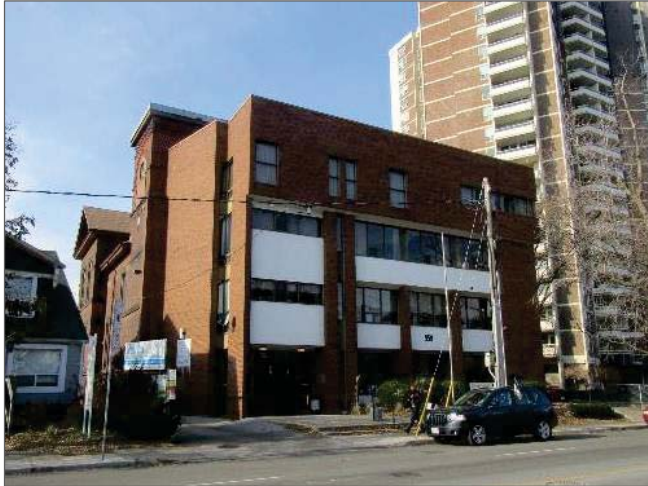
**FINAL**  
**Condition Assessment of  
the Mechanical and  
Electrical Systems**

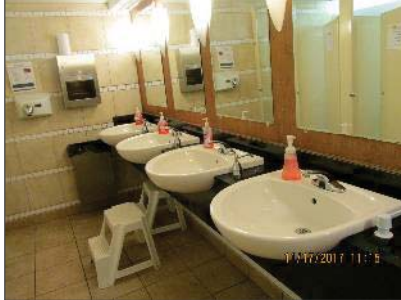
View of counter mounted lavatories – Basement Phase 1.

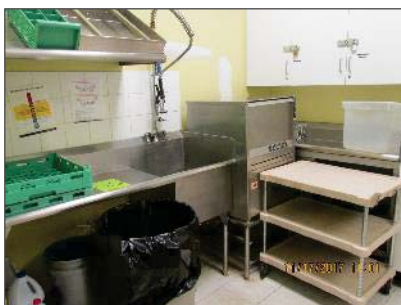
Single compartment stainless steel kitchen sink in the Kitchen area – Phase 1.

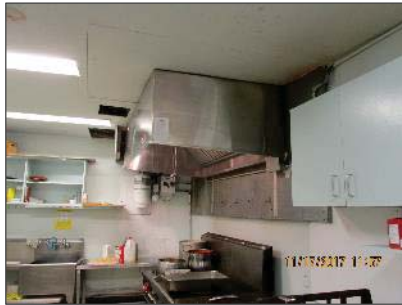
Single compartment stainless steel kitchen sink in the Kitchen area – Phase 2.

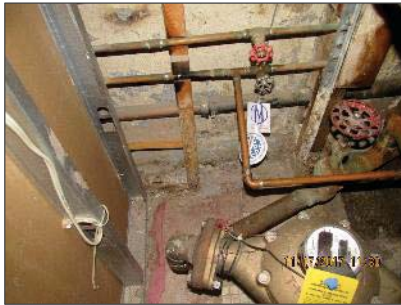
Domestic water line entering building in the basement of Phase 1. Incoming water service is not protected by a backflow preventer.

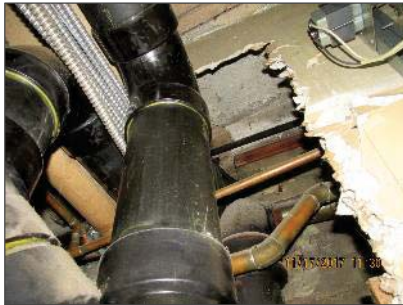
View of sanitary waste located in the basement.

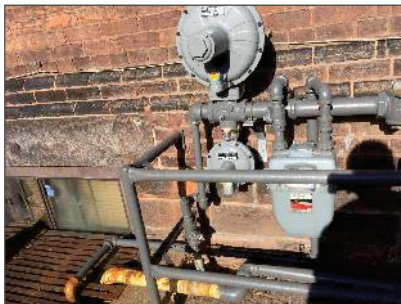
View of one natural gas service.

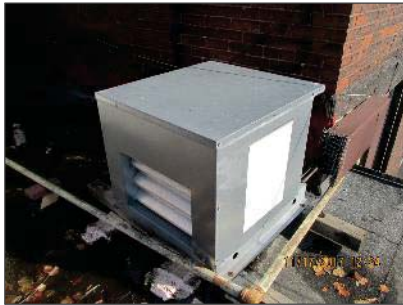
View of rusted gas line on the roof.

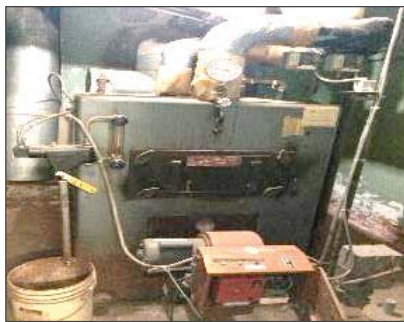
View of steam boiler (Phase 1).

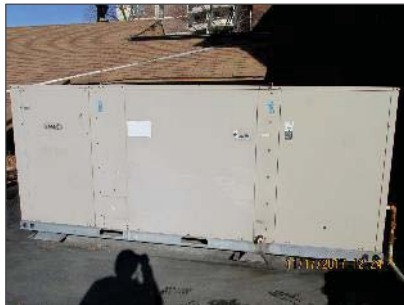
View of rooftop HVAC units (RTU-1 Phase 2 Chrystal Hall).

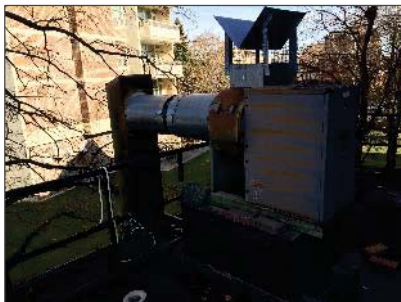
View of the kitchen exhaust fan (Phase 1).
