**FINAL**  
**Baseline Property Condition**  
**Assessment with Specialist**  
**Reviews of the Mechanical and**  
**Electrical Systems**

958 Broadview Avenue,  
Toronto, Ontario

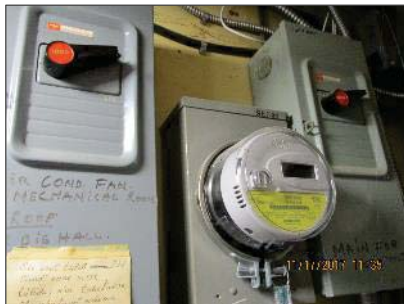
View of electrical disconnect located in the first basement electrical room.

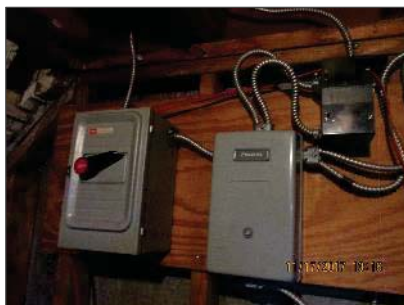
View of electrical disconnect.

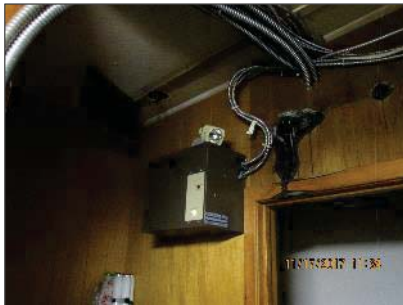
Electrical liquid tight flex cabling and conduit installation.

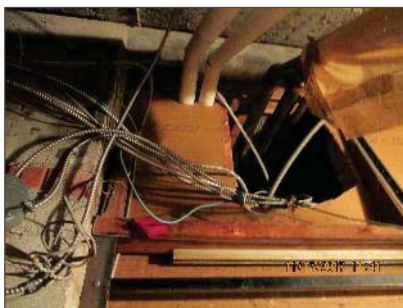
Electrical conduit installation.

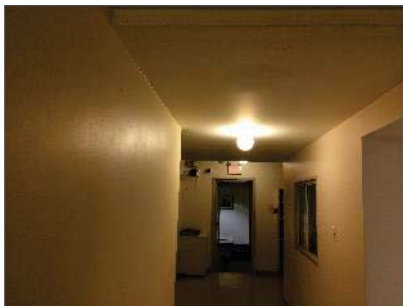
View of the fixtures observed in common area.

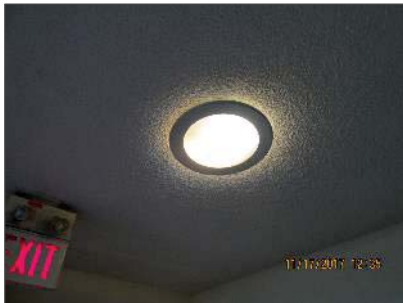
View of pot light fixtures.

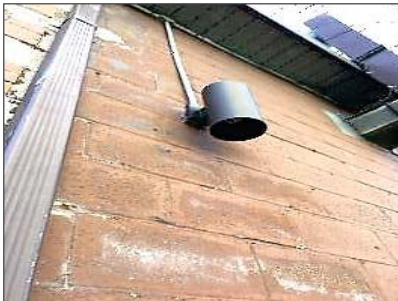
Exterior wall mounted general lighting.
